What is the diagnosis?

CASE PRESENTATION

Paced right bundle branch block pattern in an elderly woman

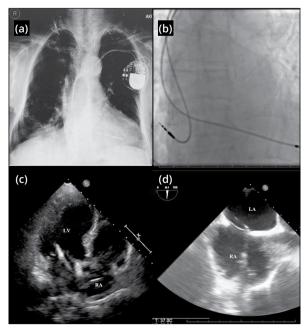
An 82-year-old female was hospitalized for pneumonia and mental confusion in the internal medicine clinic 1.5 year ago. Her electrocardiogram (ECG) revealed a third-degree AV block (Fig. 1a), and she was referred to the external center for a pacemaker implantation. After one year from the pacemaker implantation, the patient came to control. Baseline ECG was in pacemaker rhythm with a right bundle branch block (RBBB) pattern (Fig. 1b). The patient underwent a chest radiography to rule out electrode malposition (Fig. 2a). Fluoroscopic, transthoracic echocardiography (TTE), and transesophageal echocardiography (TEE) images are shown in Figures 2b, 2c and 2d, respectively. What is the most likely diagnosis of this electrocardiographic appearance?

Figure 1. (a) The electrocardiogram before pacemaker implantation. (b) The admission electrocardiogram. RA: right atrium; LA: left atrium; LV: left ventricle.
